# Manhole Inspection Summary

Manhole # S23GG1008MH

Insp Date: **12/7/06 12:53 PM**

**Location** Address: **1401 Weldon -Buena Vista**

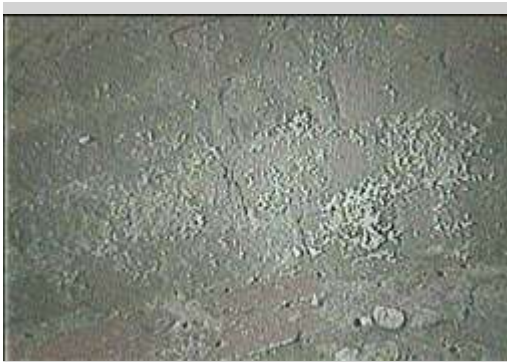
Defect

Infiltration: ☐ None ☐ Joint ☐ Cracks ☒ **Mortar** ☐ Roots ☒ **Wall**

Barrel infiltration

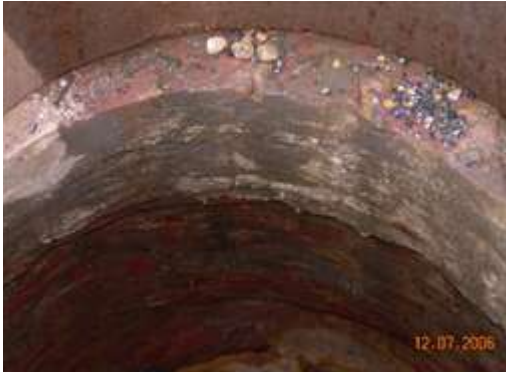
Defect

Infiltration: ☐ None ☒ **Joint** ☐ Cracks ☒ **Mortar** ☐ Roots ☐ Wall

Adjustment and barrel infiltration

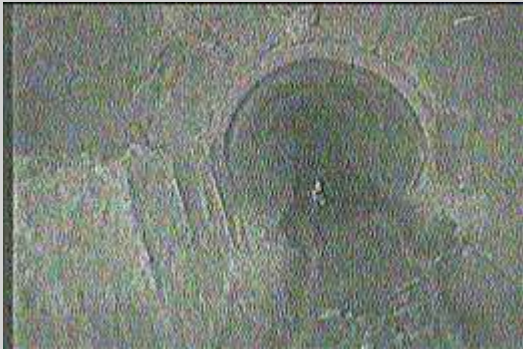
### 8 in. Circular Gravity Sewer Pipe Out @ 12 O'Clock

Infiltration: **None** Pipe Seal Cond: **Sound**

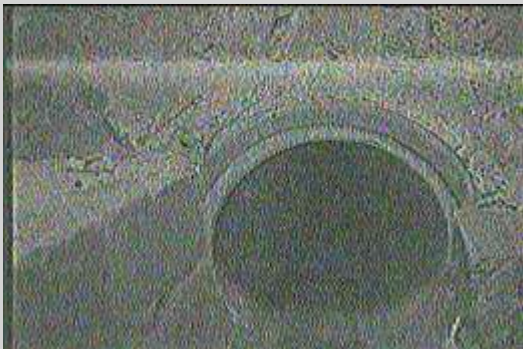
### 8 in. Circular Gravity Sewer Pipe In @ 6 O'Clock

Infiltration: **None** Pipe Seal Cond: **Sound**

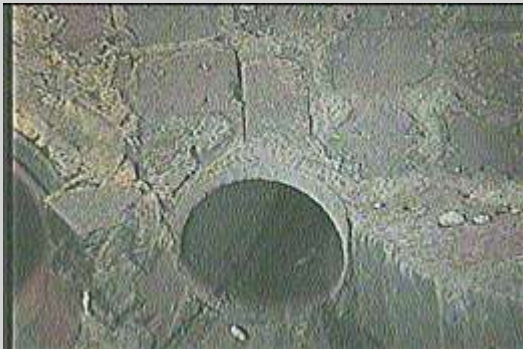
6 in. Circular Gravity Sewer  
Pipe In @ 7 O'Clock

Infiltration: **None** Pipe Seal Cond: **Sound**
